Infrared Inspection Report

AI Lectric Electrical Contracting Corp

Inspection date: 3/27/16
Report Date: 3/28/16
Type of Inspection:

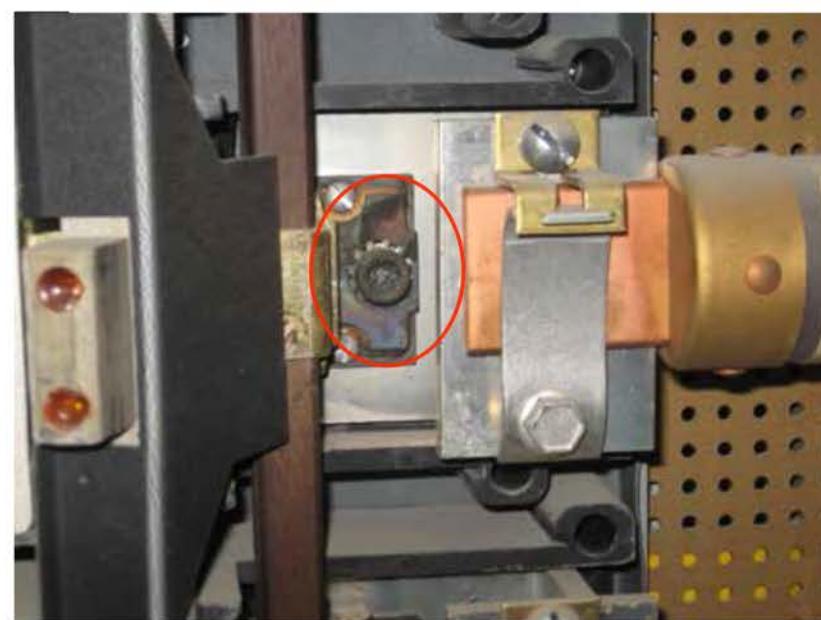
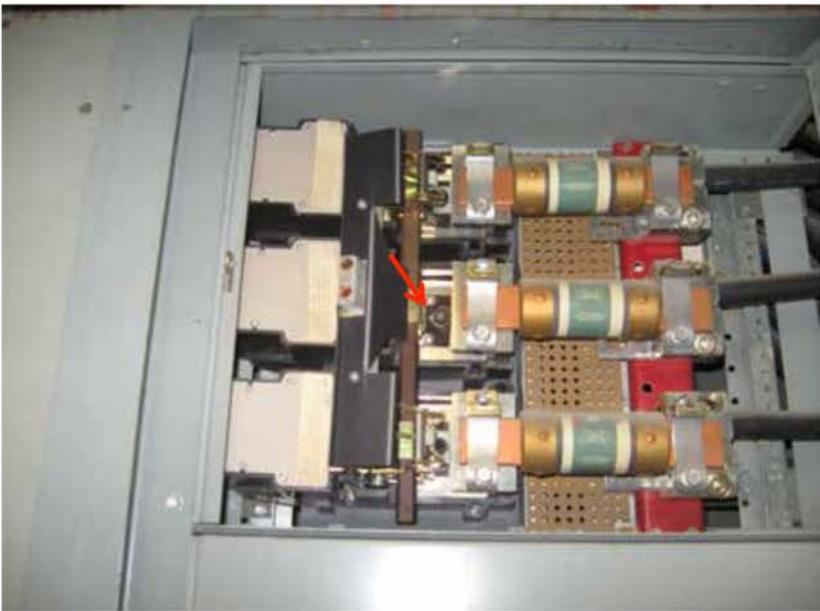
No.	17	Job Number			Equip #	14th Floor	
Location	Main Electric Room				Wind Speed	Indoor	
Equipment	Switchgear - 400A Fused DS				From		
Lens	1X	Filter	None				
Rated Load (Amps)			Meas. (Amps)			% load	
						Degree Rise (C°)	
						Rise Over	Ambient
Amps "A"=							
Amps "B"=							
Amps "C"=	<p>"B" phase screw appeared to once have been overheated, same for all "B" screws in this section of Switchgear equipment, not hot at time of Infrared inspection</p>						
Obj Priority NETA	<input type="checkbox"/>	Subj. Priority	4	Avg Priority	4		
Obj Pr. Ex-Based	<input type="checkbox"/>	Subj. Priority		Avg Priority

CORRECTIVE ACTION
Possible deficiency; warrants investigation

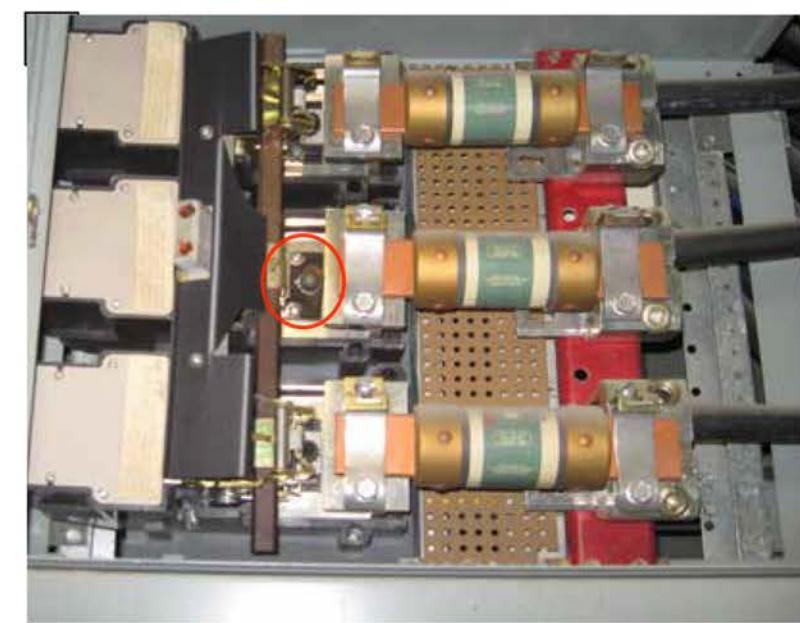
No.	18	Job Number			Equip #	16th Floor	
Location	Main Electric Room				Wind Speed	Indoor	
Equipment	Switchgear - 400A Fused DS				From		
Lens	1X	Filter	None				
Rated Load (Amps)			Meas. (Amps)			% load	
Degree Rise (C°)			Rise Over			Ambient	
Amps "A"=							
Amps "B"=							
Amps "C"=			"B" phase screw appeared to once have been overheated, same for all "B" screws in this section of Switchgear equipment, not hot at time of Infrared inspection				
Obj Priority NETA			Subj. Priority	4		Avg Priority	4
Obj Pr. Ex-Based			Subj. Priority			Avg Priority

CORRECTIVE ACTION
Possible deficiency; warrants investigation

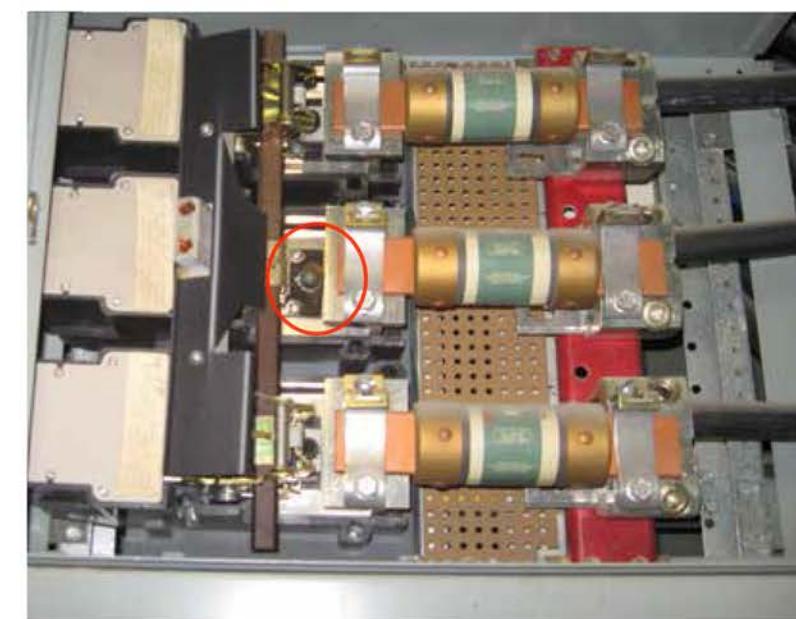
No.	19	Job Number			Equip #	15th Floor	
Location	Main Electric Room				Wind Speed	Indoor	
Equipment	Switchgear - 400A Fused DS				From		
Lens	1X	Filter	None				
Rated Load (Amps)			Meas. (Amps)			% load	
						Degree Rise (C°)	
						Rise Over	Ambient
Amps "A"=							
Amps "B"=							
Amps "C"=					<p>"B" phase screw appeared to once have been overheated, same for all "B" screws in this section of Switchgear equipment, not hot at time of Infrared inspection</p>

CORRECTIVE ACTION
Possible deficiency; warrants investigation

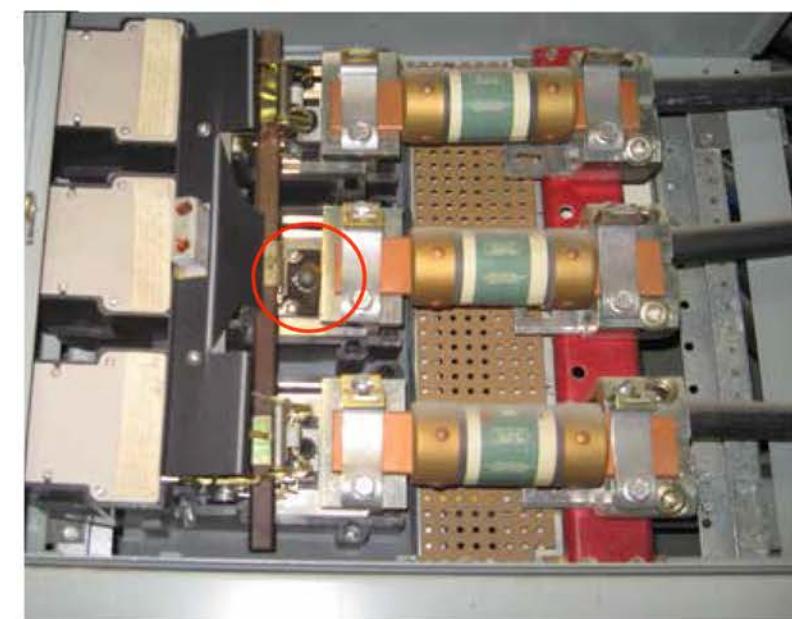
No.	20	Job Number			Equip #	17th Floor	
Location	Main Electric Room				Wind Speed	Indoor	
Equipment	Switchgear - 400A Fused DS				From		
Lens	1X	Filter	None				
Rated Load (Amps)			Meas. (Amps)			% load	
						Degree Rise (C°)	Rise Over
Amps "A"=							
Amps "B"=							
Amps "C"=					<p>"B" phase screw appeared to once have been overheated, same for all "B" screws in this section of Switchgear equipment, not hot at time of Infrared inspection</p>		
Obj Priority NETA			Subj. Priority	4		Avg Priority	4
Obj Pr. Ex-Based			Subj. Priority			Avg Priority

CORRECTIVE ACTION
Possible deficiency; warrants investigation

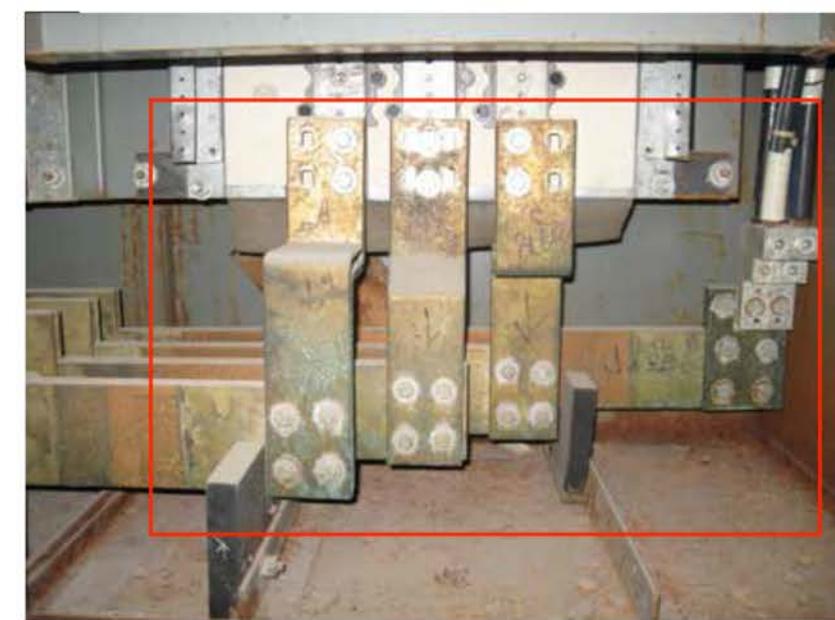
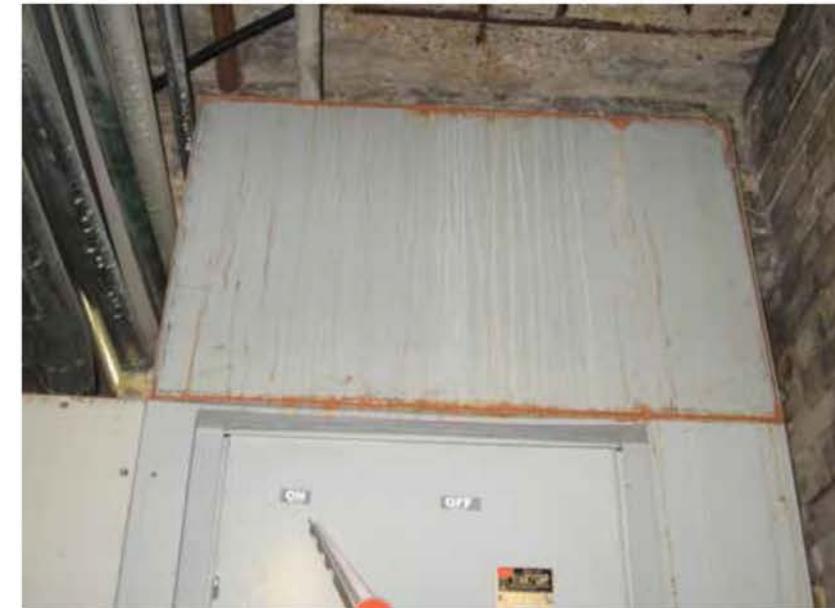
Load appeared to be lighting in the building. In switchgear section #7 all the screws on the "B" phase switches (items 17-20) looked burnt. Something systematic must have happened to this section of gear.

No.	27	Job Number		Equip #	Section 7
Location	Main Electric Room			Wind Speed	
Equipment	Switchgear Busswork Rear			From	
Lens	1X	Filter	None		
Rated Load (Amps)			Meas. (Amps)		% load
Degree Rise (C°) Rise Over					
Amps "A"=					
Amps "B"=					
Amps "C"=	Rust and corrosion on buss work and bolts, rust on top of cabinet, did water once drip down onto this gear?

CORRECTIVE ACTION
 Possible deficiency; warrants investigation

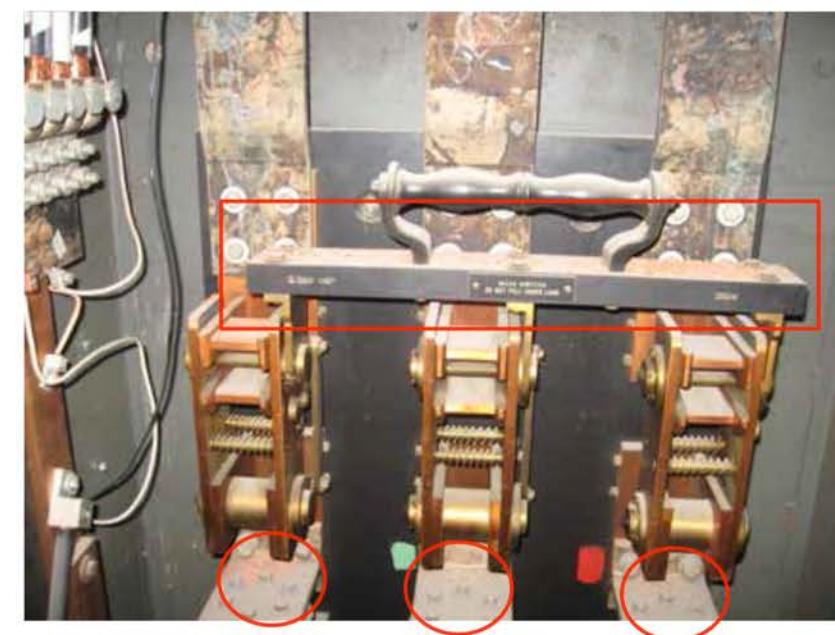
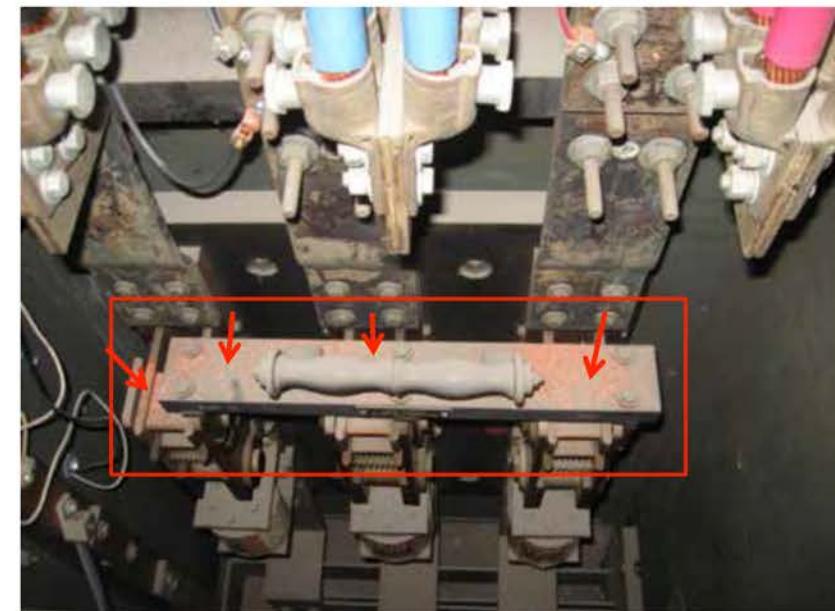
No.	28	Job Number		Equip #	SW #2
Location	Main Electric Room			Wind Speed	Indoor
Equipment	Switchgear - 2000A Fused DS			From	
Lens	1X	Filter	None		
Rated Load (Amps)		Meas. (Amps)		% load	
Degree Rise (C°)		Rise Over			
Amps "A"=					
Amps "B"=					
Amps "C"=

Copper shavings on switch, these could cause an arc flash when opening the switch. Recommend not operating switch until shavings are removed.

CORRECTIVE ACTION
Indicates probable deficiency; repair as time permits

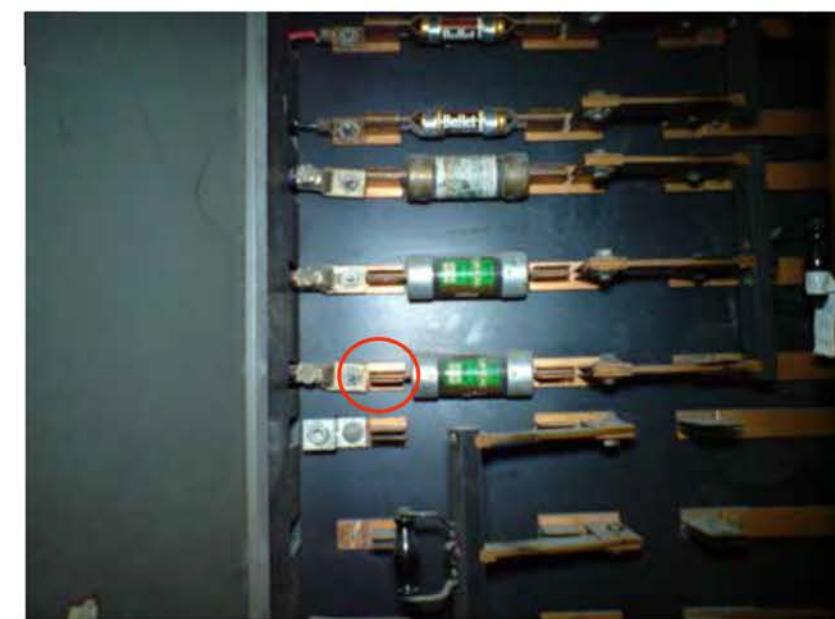
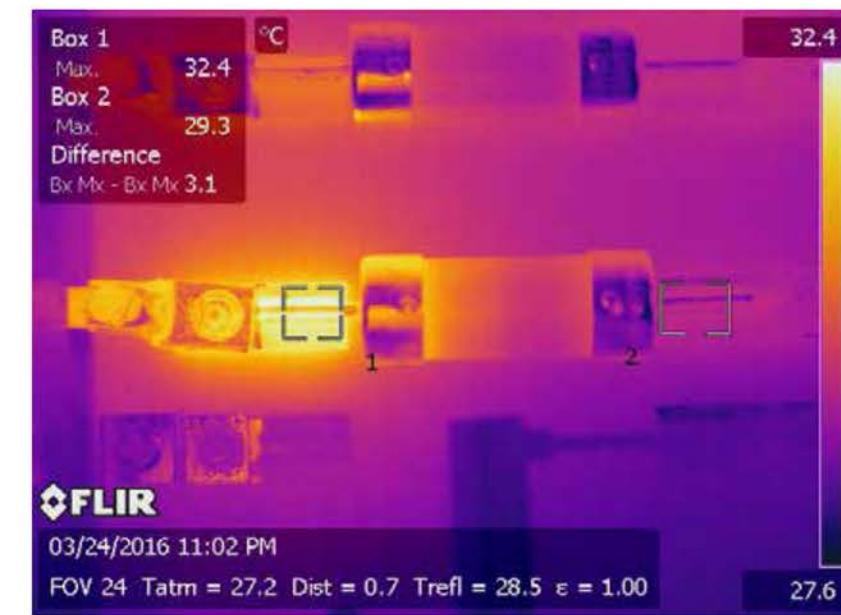
No.	29	Job Number			Equip #	SWBD #1
Location	Main Electric Room			Wind Speed	Indoor	
Equipment	Switchgear Fuse Board			From		
Lens	1X	Filter	None			
Rated Load (Amps)	100A	Meas. (Amps)	NA	% load		
Degree Rise (C°)		3.1	Rise Over	Similar component/load		
Amps "A" =	NA	Possible issue with fuse clip or connection on "B" phase, check and confirm repair.				
Amps "B" =						
Amps "C" =

CORRECTIVE ACTION
Indicates probable deficiency; repair as time permits

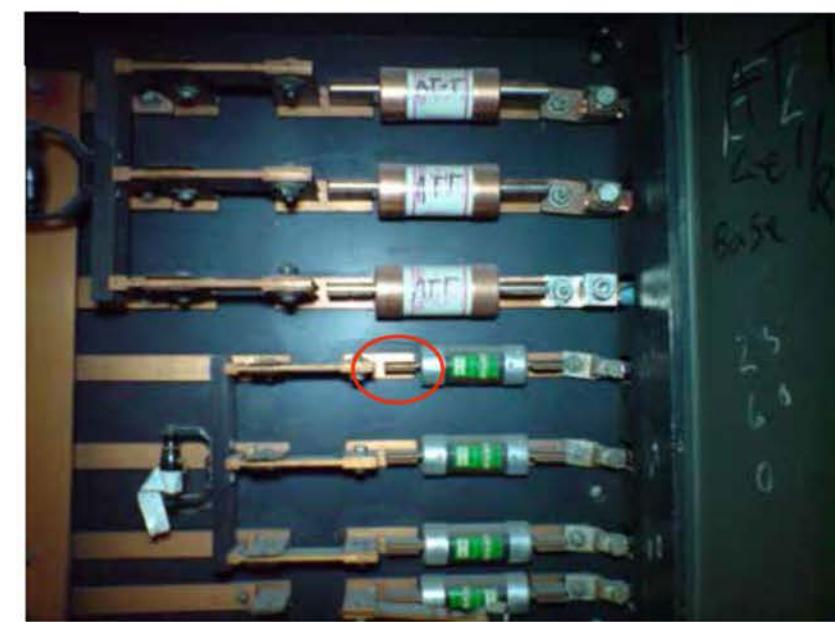
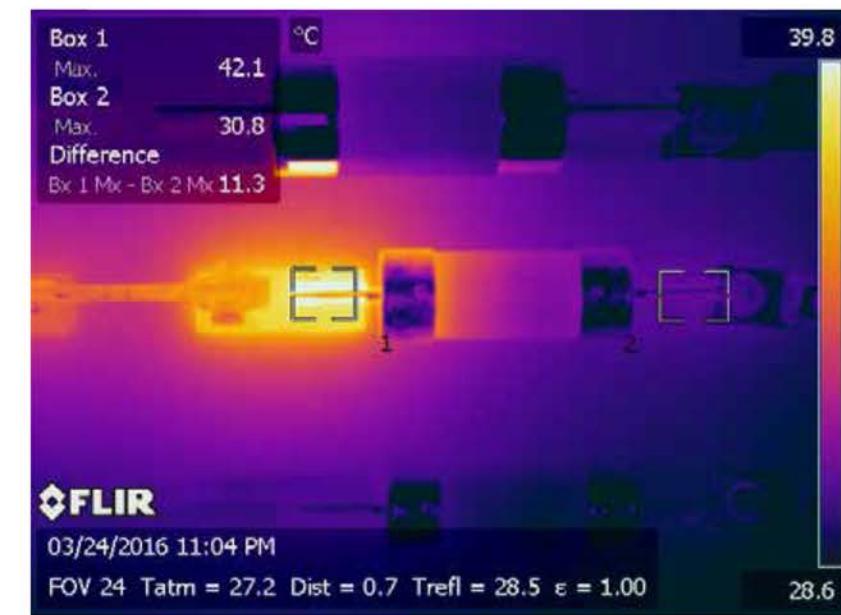
No.	30	Job Number			Equip #	SWBD #1
Location	Main Electric Room			Wind Speed	Indoor	
Equipment	Switchgear Fuse Board			From		
Lens	1X	Filter	None			
Rated Load (Amps)	200A	Meas. (Amps)	NA	% load		
Degree Rise (C°)		11.3	Rise Over	Similar component/load		
Amps "A"=	NA	Possible issue with fuse clip, or connection on "A" phase", check and confirm repair.				
Amps "B"=						
Amps "C"=

CORRECTIVE ACTION
Indicates probable deficiency; repair as time permits

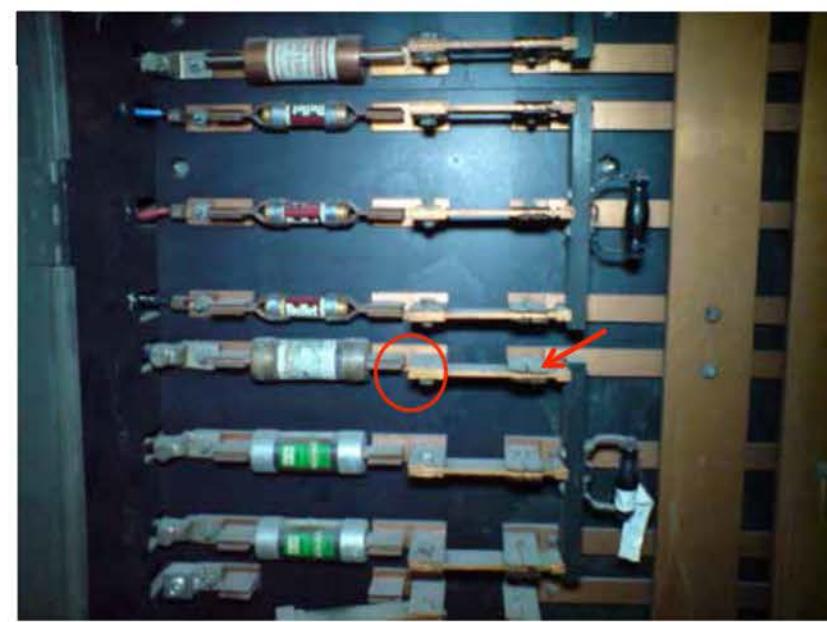
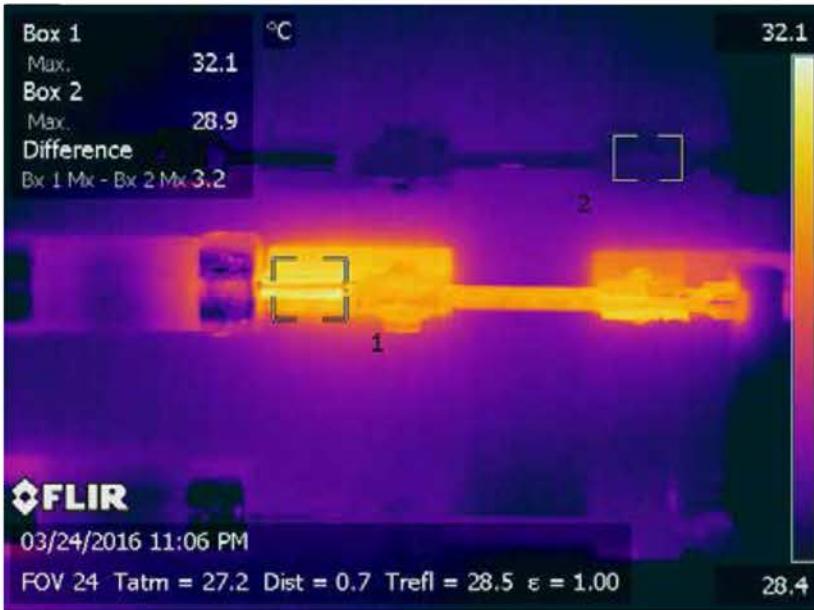
No.	31	Job Number			Equip #	SWBD #1
Location	Main Electric Room			Wind Speed	Indoor	
Equipment	Switchgear Fuse Board			From		
Lens	1X	Filter	None			
Rated Load (Amps)	200A	Meas. (Amps)	NA	% load		
Degree Rise (C°)		3.2	Rise Over	Ambient		
Amps "A" =	Possible issue with fuse clip, or connection on "A" phase", check and confirm repair.					
Amps "B" =						
Amps "C" =	Possible issue with switch contact (red arrow).					
Obj Priority NETA Obj Pr. Ex-Based	4	Subj. Priority Subj. Priority			Avg Priority Avg Priority	4

CORRECTIVE ACTION
Possible deficiency; warrants investigation

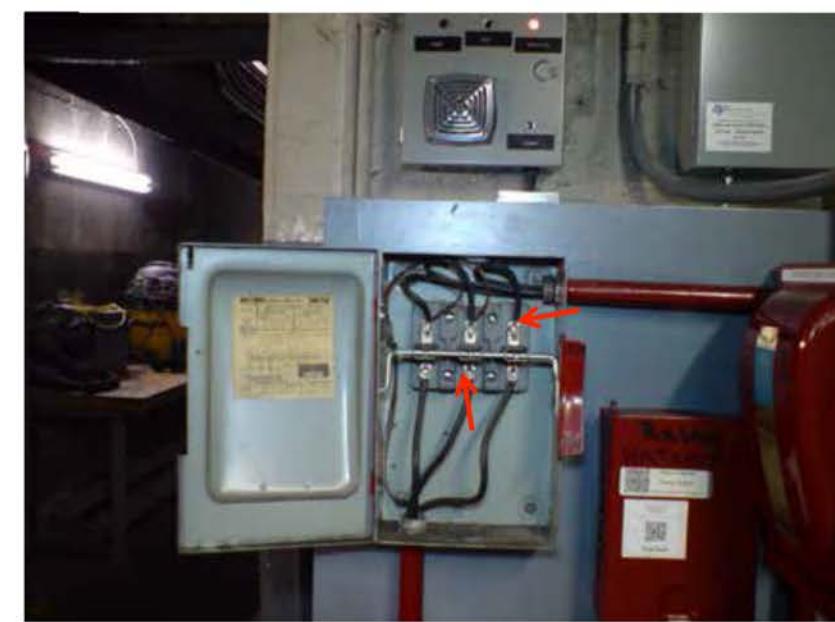
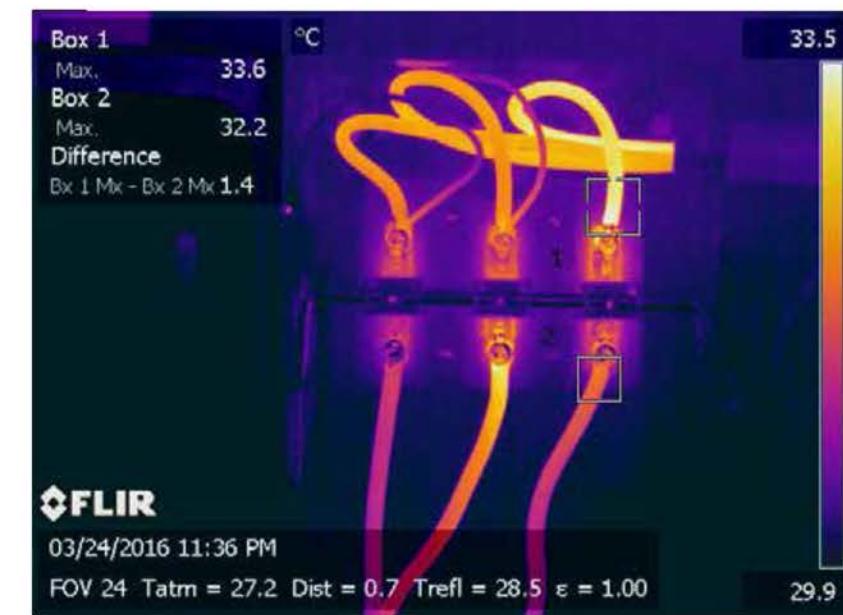
No.	35	Job Number				
Location	Boiler Room			Wind Speed	Indoor	
Equipment	60A Disconnect Switch			From		
Lens	1X	Filter	None			
Rated Load (Amps)	60	Meas. (Amps)	36	% load	60.00%	
Degree Rise (C°)		1.4	Rise Over	Similar component/load		
Amps "A"=	36	Enter comment				
Amps "B"=	36					
Amps "C"=	36	Temp rise is small, but could not run pumps for adequate time to allow switch to heat up. Recommend to tighten all connections and clean switch.				
Obj Priority NETA	4	Subj. Priority			Avg Priority	4
Obj Pr. Ex-Based		Subj. Priority			Avg Priority

Possible deficiency; warrants investigation

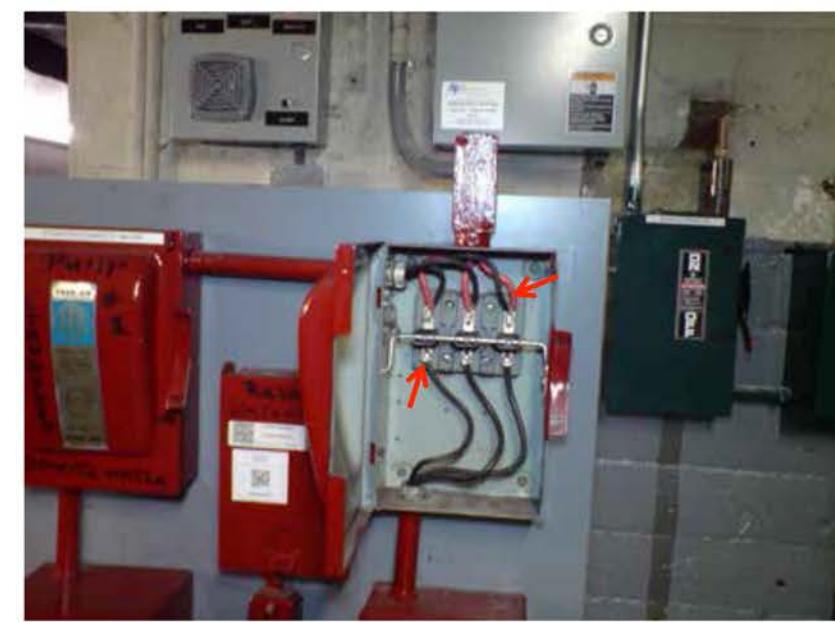
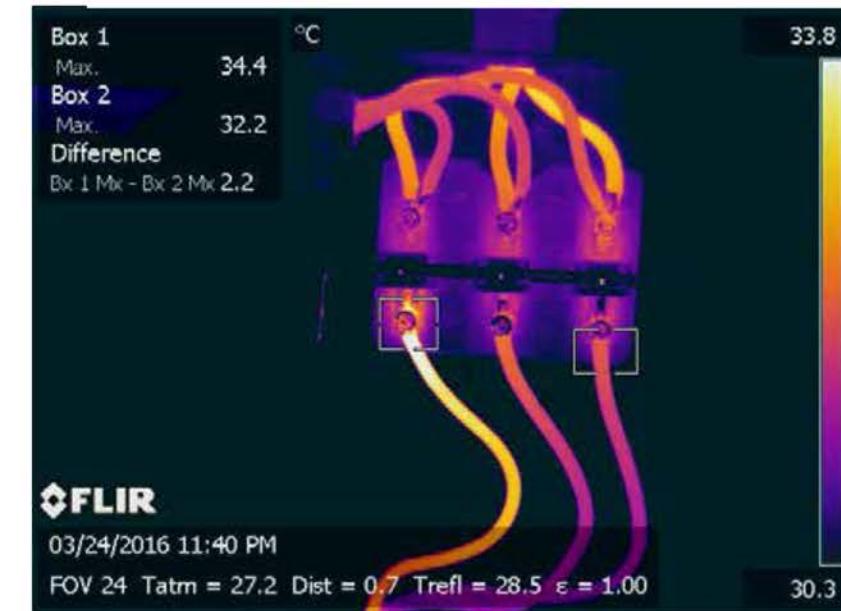
No.	36	Job Number				
Location	Boiler room			Wind Speed	Indoor	
Equipment	60A Disconnect Switch			From		
Lens	1X	Filter	None			
Rated Load (Amps)	60	Meas. (Amps)	33	% load	55.00%	
Degree Rise (C°)		2.2	Rise Over	"C" Phase		
Amps "A"=	33	Enter comment				
Amps "B"=	33					
Amps "C"=	33	Temp rise is small, but could not run pumps for adequate time to allow switch to heat up. Recommend to tighten all connections and clean switch.				
Obj Priority NETA	4	Subj. Priority			Avg Priority	4
Obj Pr. Ex-Based		Subj. Priority			Avg Priority	4

Possible deficiency; warrants investigation

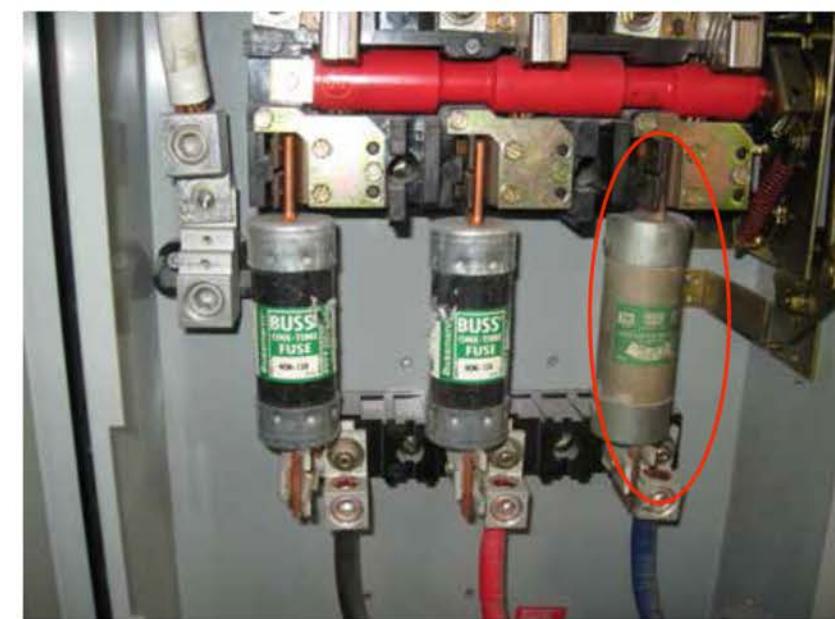
No.	37	Job Number			Equip #	Car 3	
Location	Elevator Room #2				Wind Speed	Indoor	
Equipment	200A Fused Disconnect Switch				From		
Lens	1X	Filter	None				
Rated Load (Amps)			Meas. (Amps)			% load	
Degree Rise (C°) _____ Rise Over _____							
Amps "A"=	150	Enter comment					
Amps "B"=	150						
Amps "C"=	200	Mismatched fuse on "C". "A" and "B" are 150A. "C" should be 150A, is 200A. "C" also looked burnt, recommend correct fuse and clean/service switch

CORRECTIVE ACTION
Indicates probable deficiency; repair as time permits

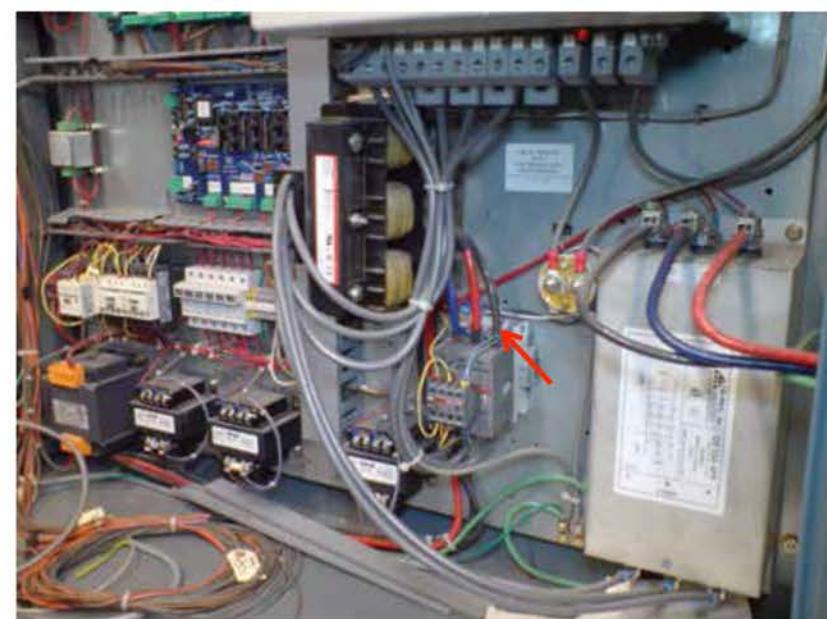
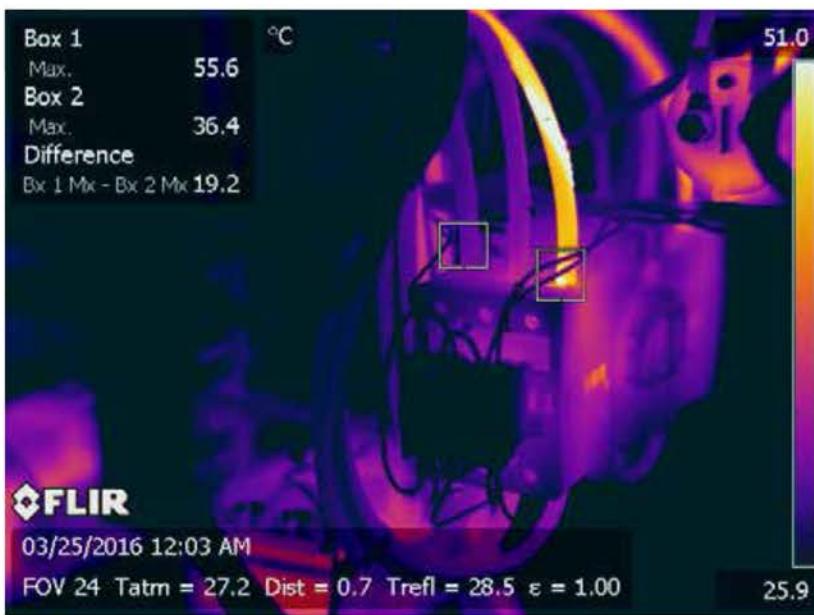
No.	43	Job Number			Equip #	Car #1		
Location	Elevator Room #1				Wind Speed	Indoor		
Equipment	Control Cabinet				From			
Lens	1X	Filter	None					
Rated Load (Amps)			Meas. (Amps)			% load		
Degree Rise (C°)		19.2		Rise Over	"A" Phase			
Amps "A" =	Enter comment							
Amps "B" =								
Amps "C" =	NA	Warm connection on "C" phase (Ctrl cabinet on the right)						
Obj Priority NETA	1	Subj. Priority			Avg Priority	1		
Obj Pr. Ex-Based		Subj. Priority			Avg Priority

CORRECTIVE ACTION
Major discrepancy; repair immediately

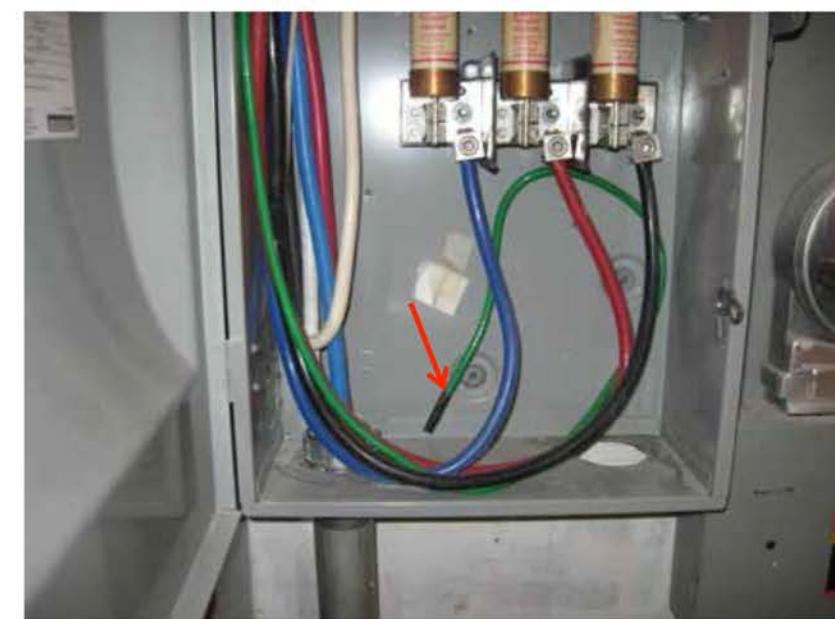
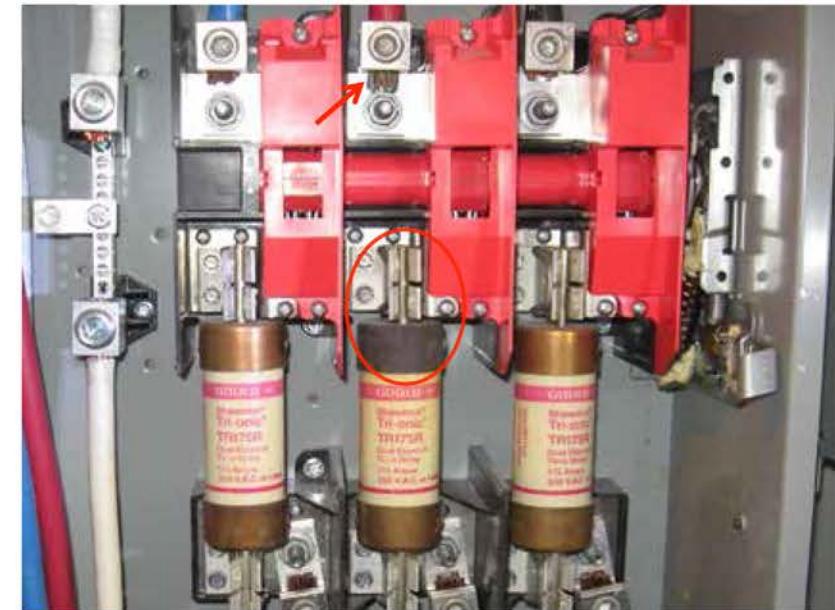
No.	51	Job Number			Equip #	MAIN	
Location	15th Floor Electric Closet				Wind Speed	Indoor	
Equipment	200A Fused Disconnect Switch				From		
Lens	1X	Filter	None				
Rated Load (Amps)			Meas. (Amps)			% load	
Degree Rise (C°)				Rise Over			
Amps "A"=	<input type="text"/> Enter comment						
Amps "B"=	<input type="text"/>						
Amps "C"=	<input type="text"/> Missing ground. "B" phase wire corroded.. "B" phase fuse discolored. This switch appeared to have been overheated. Not hot at time of infrared inspection, recommend servicing switch.						
Obj Priority NETA	<input type="text"/>	Subj. Priority	3	Avg Priority	3		
Obj Pr. Ex-Based	<input type="text"/>	Subj. Priority		Avg Priority

Indicates probable deficiency; repair as time permits

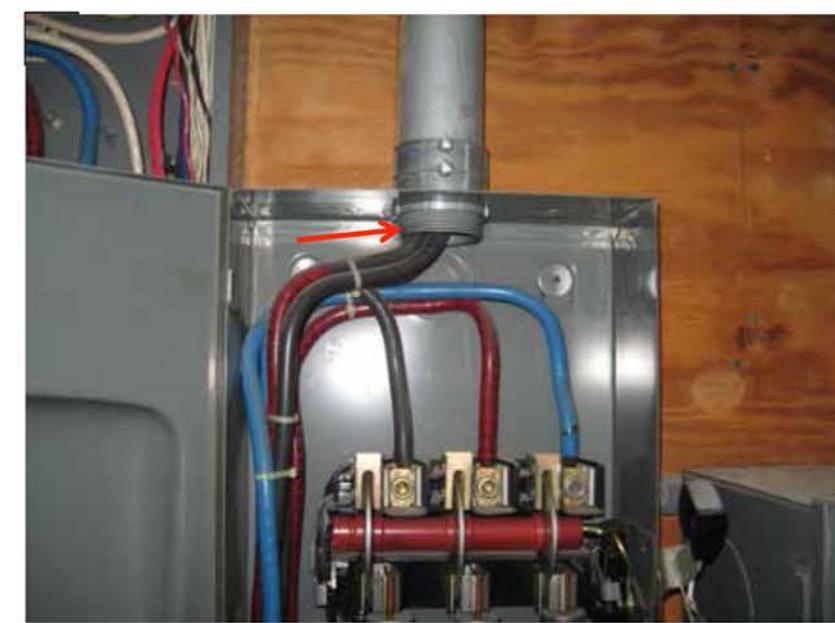
No.	55	Job Number			Equip #	Panel #3
Location	14 Floor Electrical Closet			Wind Speed	Indoor	
Equipment	200A Fused Disconnect Switch			From		
Lens	1X	Filter	None			
Rated Load (Amps)			Meas. (Amps)			% load
Degree Rise (C°)				Rise Over		
Amps "A"=	<input type="text"/> <input type="text"/> <input type="text"/>					
Amps "B"=						
Amps "C"=	<input type="text"/> <p>Enter comment</p> <p>No Bushing, Electrician says this is a safety violation</p>					
Obj Priority NETA Obj Pr. Ex-Based	<input type="text"/>	Subj. Priority Subj. Priority	<input type="text"/> 4	Avg Priority Avg Priority	<input type="text"/> 4	
Repair Chk Date			Rise Over

CORRECTIVE ACTION
Possible deficiency; warrants investigation

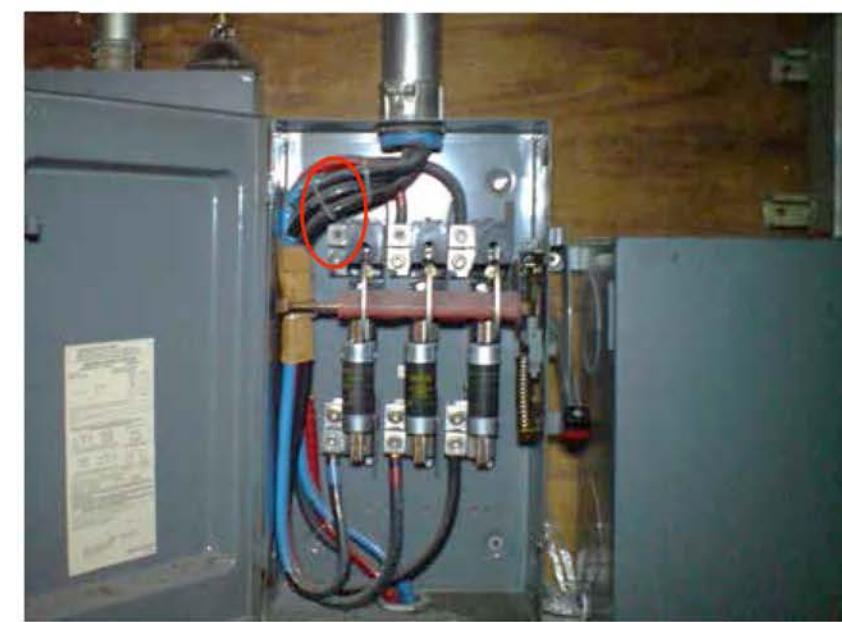
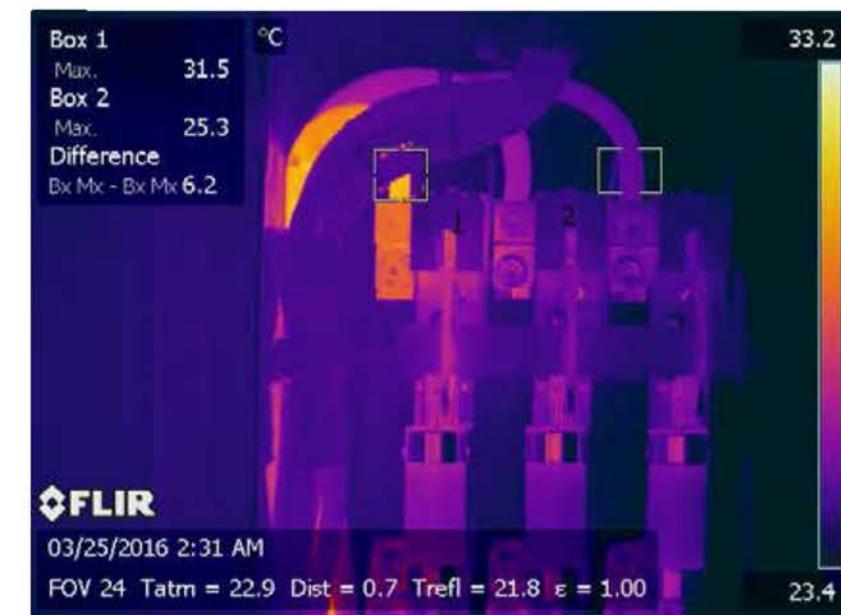
No.	57	Job Number			Equip #	AC1	
Location	12th Floor Electrical Closet				Wind Speed	Indoor	
Equipment	200A Fused Disconnect Switch				From		
Lens	1X	Filter	None				
Rated Load (Amps)	200	Meas. (Amps)	11	% load	5.50%		
Degree Rise (C°)		6.2	Rise Over	"C" Phase			
Amps "A"=	11	Enter comment					
Amps "B"=	11						
Amps "C"=	12	Possible loose connection on "A" phase					
Obj Priority NETA	3	Subj. Priority			Avg Priority	3	
Obj Pr. Ex-Based		Subj. Priority			Avg Priority	3

CORRECTIVE ACTION
Indicates probable deficiency; repair as time permits

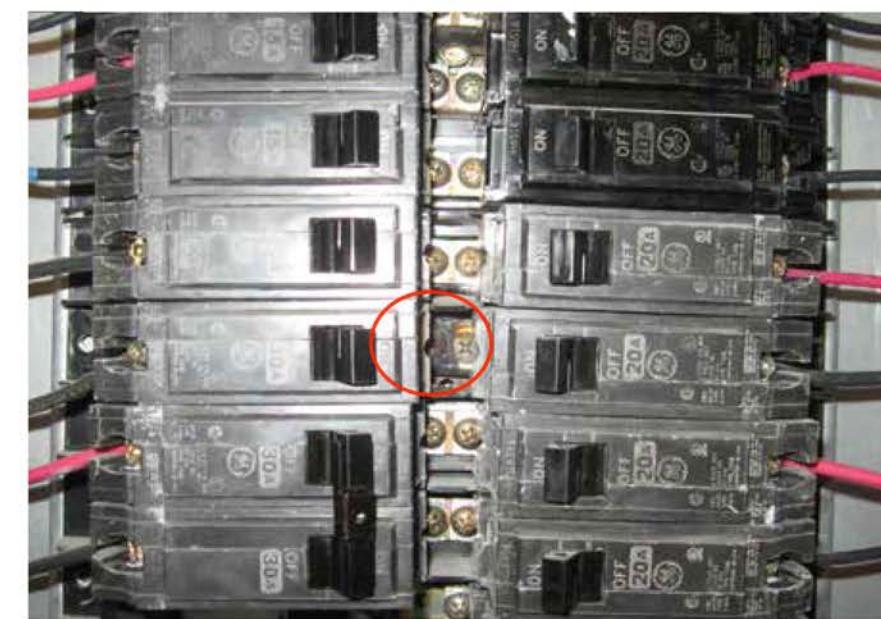
No.	83	Job Number			Equip #	PP1
Location	7th Floor Electrical Closet			Wind Speed	Indoor	
Equipment	Circuit Breaker Panel			From		
Lens	1X	Filter	None			
Rated Load (Amps)	30	Meas. (Amps)			% load	
Degree Rise (C°)				Rise Over		
Amps "A"=	<input type="text"/> <input type="text"/> <input type="text"/>					
Amps "B"=						
Amps "C"=	<input type="text"/> <input type="text"/> <input type="text"/>					
Obj Priority NETA	<input type="text"/>	Subj. Priority	2	Avg Priority	2	
Obj Pr. Ex-Based	<input type="text"/>	Subj. Priority	<input type="text"/>	Avg Priority	<input type="text"/>	
Repair Chk Date	<input type="text"/>		Rise Over	<input type="text"/>

CORRECTIVE ACTION
 Monitor until corrective measures can be accomplished

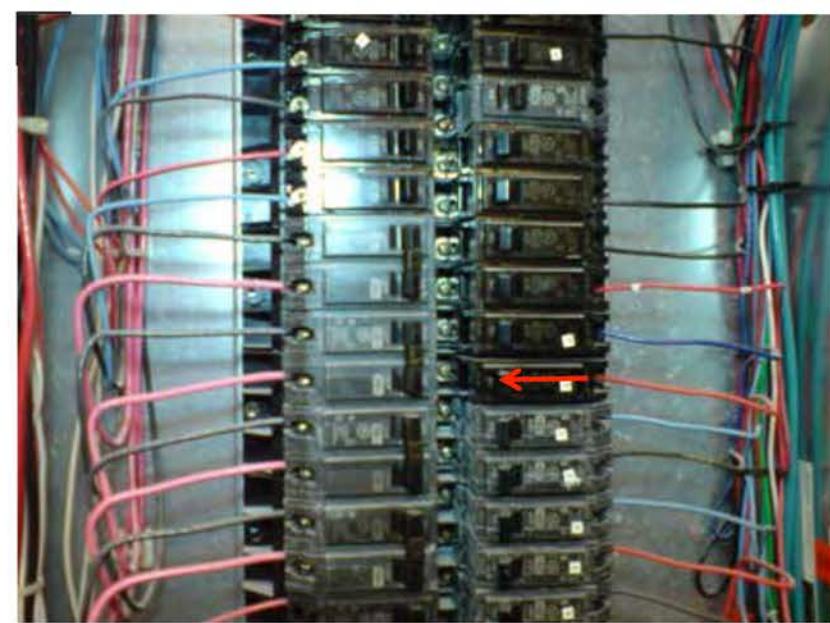
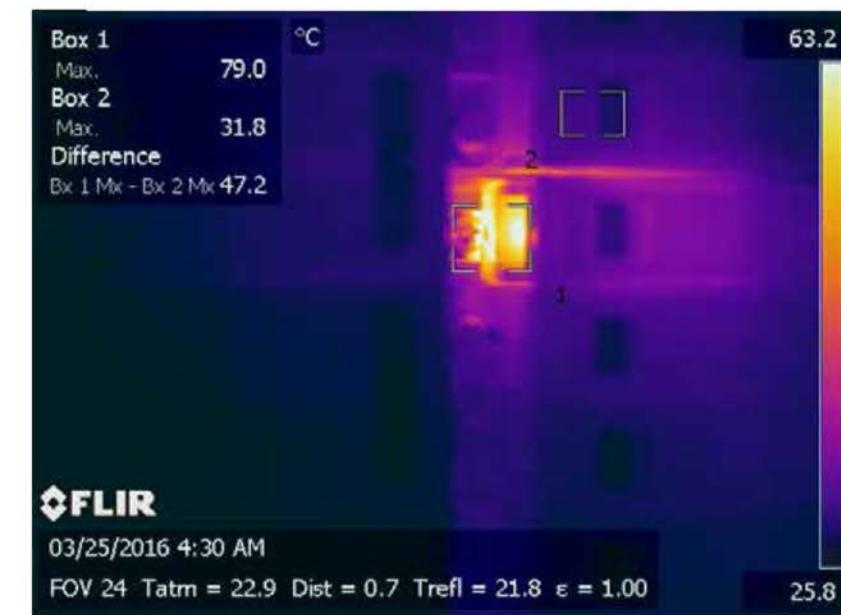
No.	87	Job Number			Equip #	PL-2
Location	6th Floor Electrical Closet			Wind Speed	Indoor	
Equipment	Circuit Breaker Panel			From		
Lens	1X	Filter	None			
Rated Load (Amps)	20	Meas. (Amps)	4.7	% load	23.50%	
Degree Rise (C°)	47.2	Rise Over	Ambient			
Amps "A"=						
Amps "B"=						
Amps "C"=	Possible issue with connection to backplane or internal breaker issue #20, recommend replace breaker.					
Obj Priority NETA Obj Pr. Ex-Based	1	Subj. Priority Subj. Priority			Avg Priority Avg Priority	1

CORRECTIVE ACTION
Major discrepancy; repair immediately

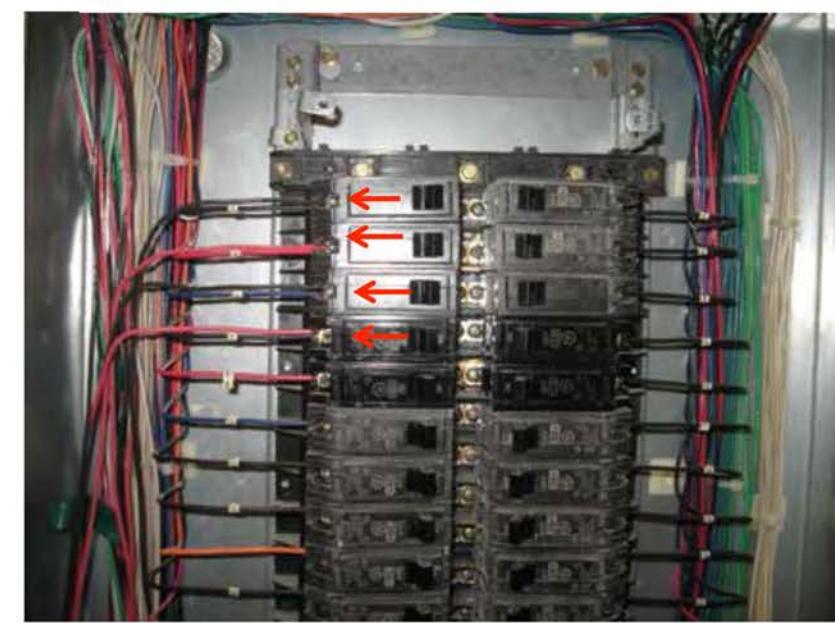
No.	90	Job Number			Equip #	A		
Location	5th Floor Electrical Closet			Wind Speed	Indoor			
Equipment	Circuit Breaker Panel			From				
Lens	1X	Filter	None					
Rated Load (Amps)			Meas. (Amps)			% load		
Degree Rise (C°)			Rise Over					
Amps "A"=	Enter comment Two wires on one breaker - Electrician states this is a code violation							
Amps "B"=								
Amps "C"=								
Obj Priority NETA	<input type="checkbox"/>	Subj. Priority	4	Avg Priority	4			
Obj Pr. Ex-Based	<input type="checkbox"/>	Subj. Priority		Avg Priority

CORRECTIVE ACTION
Possible deficiency; warrants investigation

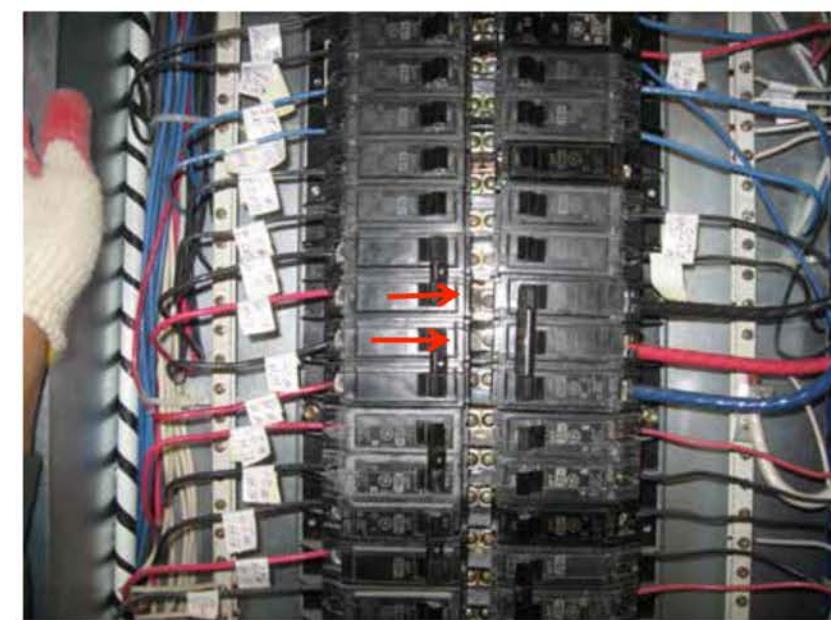
No.	96	Job Number			Equip #	A		
Location	2nd Floor Electrical Closet			Wind Speed	Indoor			
Equipment	Circuit Breaker Panel			From				
Lens	1X	Filter	None					
Rated Load (Amps)			Meas. (Amps)			% load		
Degree Rise (C°)				Rise Over				
Amps "A"=	<input type="text"/>							
Amps "B"=	<input type="text"/>							
Amps "C"=	<input type="text"/>							
Enter comment	<input type="text"/>							
Burnt backplane screws on #15 and #17, not hot at time of infrared inspection, recommend replace breaker	<input type="text"/>

CORRECTIVE ACTION
Indicates probable deficiency; repair as time permits
